Manhole Inspection Summary

Manhole # S03UU1013MH

Insp Date: **9/25/06 9:31 AM**

Location Address: **5728 CLOVER RD**

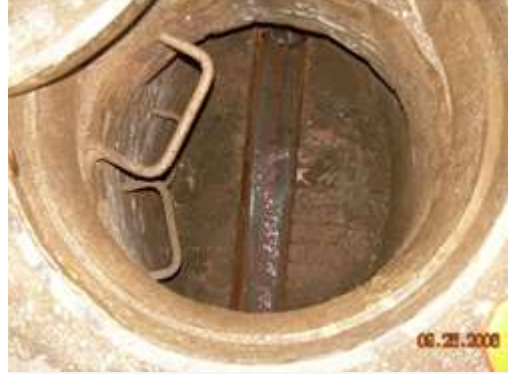
Top View

Bench ☒ Exists Material: **Brick** ☐ Parged ☒ **Debris** (not Condition related)

Surcharge ☒ **Evidence Of Surcharge** Depth: **1** (ft.) ☐ Active Surcharge Present

Evidence of surcharge - Bench debris.

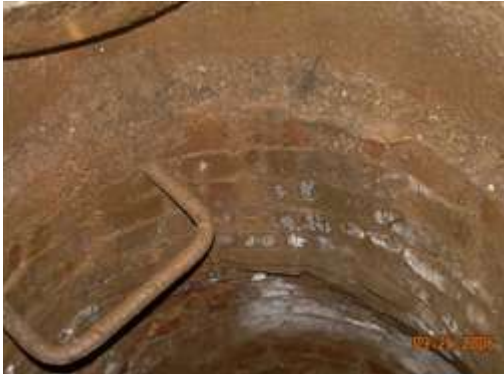
Defect

Frame Offset: **3** (in.) Condition: ☐ Sound ☐ Cracked ☒ **Leaks**

Infiltration: ☐ None ☒ **Joint** ☐ Cracks ☐ Mortar ☐ Roots ☒ **Wall**

Infiltration: ☐ None ☐ Joint ☐ Cracks ☒ **Mortar** ☐ Roots ☒ **Wall**

Frame leaks. Frame offset. Adjustment, Corbel and Barrel infiltration.

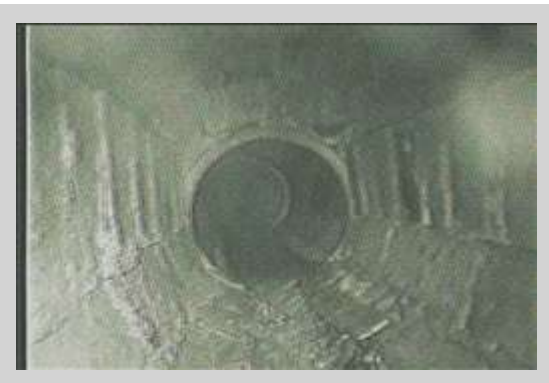
8 in. Circular Gravity Sewer Pipe In @ 6 O'Clock

Condition: ☐ Sound ☐ Cracked ☐ Root Intrusion ☒ **Deteriorated** ☐ Leaks ☐ Debris

Channel deterioration.
